NBSIR 76-1044 (R)

Selected Problems Related to the Storage of Mobile Homes for Use as Disaster Housing

April 1976

Final Report

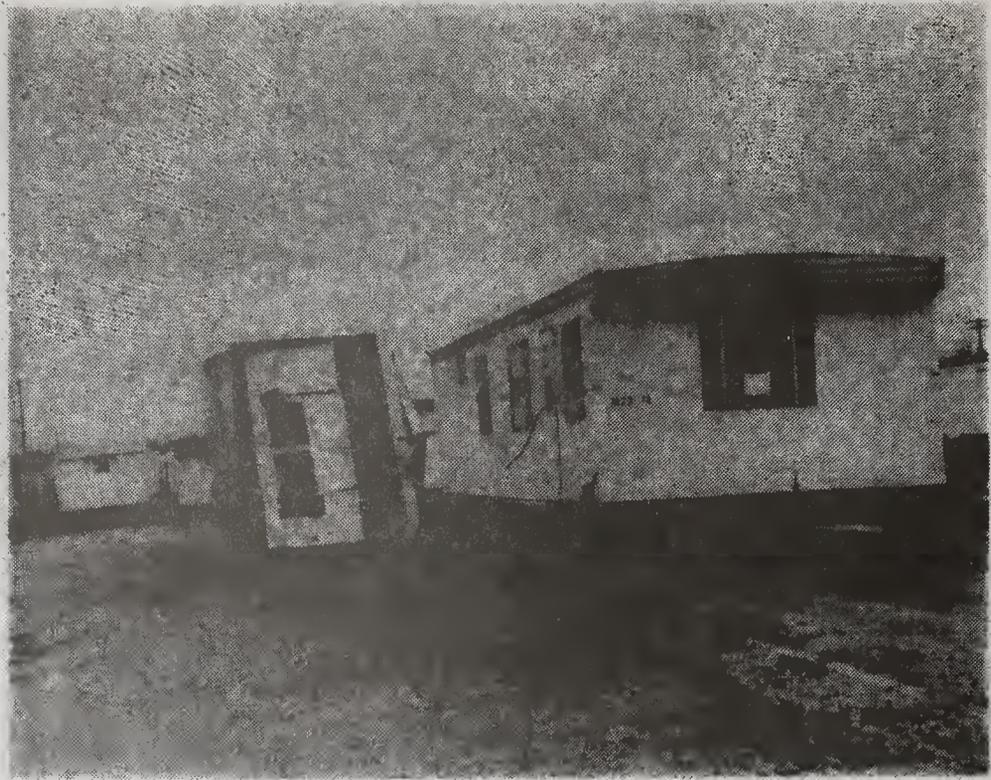
3.7 MOBILE HOME ANCHORAGE IN STORAGE. The desirability of anchoring mobile homes while in storage to reduce property damage due to high wind (figures 46 and 47) was also a study objective. In making such a judgment, it is necessary to consider many variables which, in some cases, are quite different from those encountered when anchoring occupied mobile homes.

Figure 46 Mobile Home Damage by High Winds During Storage

The anchorage of stored mobile homes would prevent or limit property damage due to high winds and is not generally associated with life safety. An economic analysis could include trade-offs in costs of anchorage systems versus the amount of damage which could be tolerated. It may not be cost effective to fully protect stored mobile homes against wind damage.
